PORTSMOUTH CIVIC CENTER

PACE Collaborative, P.C.

PACE Project #19050
April 17, 2019

CONDITION ASSESSMENT

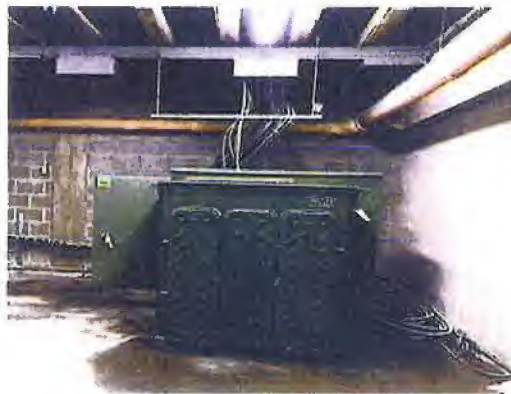
The electrical service for the Civic Center is provided from a Dominion Energy pad mounted transformer located in the basement. The area is separated from the other parking area by a chain link fence. The primary service enters the space in raceway and is run exposed through the space to the transformer. The doors to the primary section of the transformer are open to allow the primary feeder to enter the transformer. The secondary service from the transformer to the switchboard is run in feeder busway. The busway is run exposed from the transformer to the switchboard.

The electric service to the facility is rated 2500-amps, 480/277 volts, 3-phase, 4-wire. It is delivered via the Dominion Energy pad mounted transformer and busway to the incoming / metering compartment of the main switchboard. The existing switchboard is manufactured by General Electric A/V Line switchboard.

The switchboard and busway appear to be original to the building and is approximately 49 years old. The switchboard and busway are obsolete, and replacement parts would be very difficult to obtain. The switchboard is beyond the expected useful life of 30 years according to the "Building Owners and Managers Association" (BOMA).

Based on the condition and age of the switchboard, replacement is recommended.

In addition, we recommend that the service and transformer be relocated to a higher elevation to eliminate the potential for flooding.

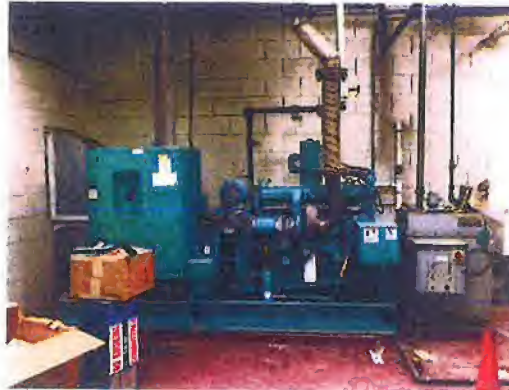
The first generator is a 230 kW at 0.8 power factor, 287.5 kVA, stand-by rated, 480/277 volts, 3-phase, 4-wire, diesel generator and is located in the basement in the mechanical /electrical room. The generator is a Cummins 230DFAB. It is water cooled via city water, which is discharged to a floor drain.

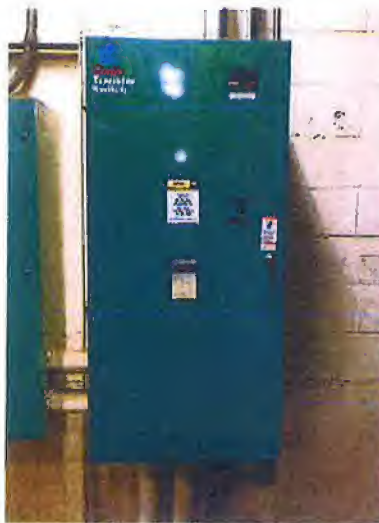
This generator feeds a 600-amps, 3-pole, 4-wire automatic transfer switch (Onan OT 600).

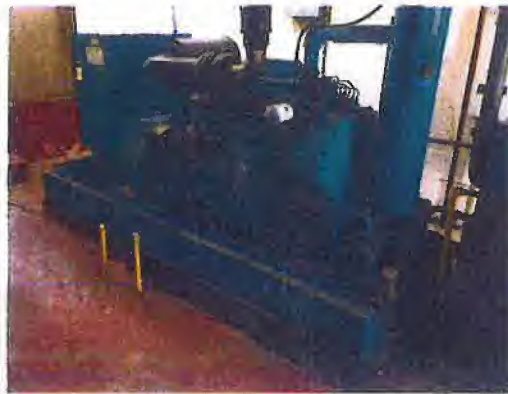
The second generator is a 150 kW at 0.8 power factor, 187.5 kVA, 480/277 volts, 3-phase, 4-wire, stand-by rated, diesel generator and is located in the basement in a separate generator room. The generator is a Cummins 150DGFA. It is water cooled via city water, which is discharged to a floor drain.

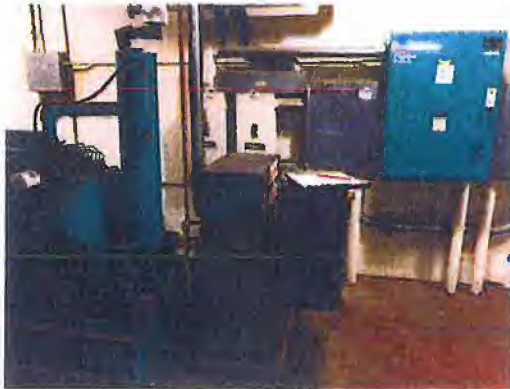
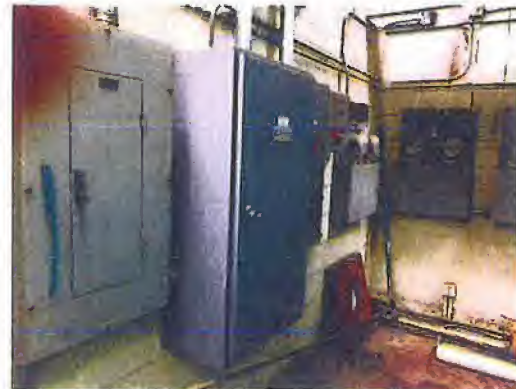
This generator feeds two 150-amps, 3-pole, 4-wire, automatic transfer switch. One automatic transfer switch is an Onan OT 150, and the other automatic transfer switch is a Zenith ZTS series.

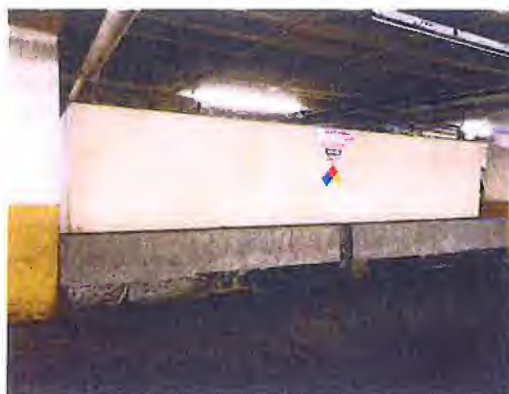
The diesel fuel is provided from an above ground, fire-rated fuel tank located in the parking garage in the basement.

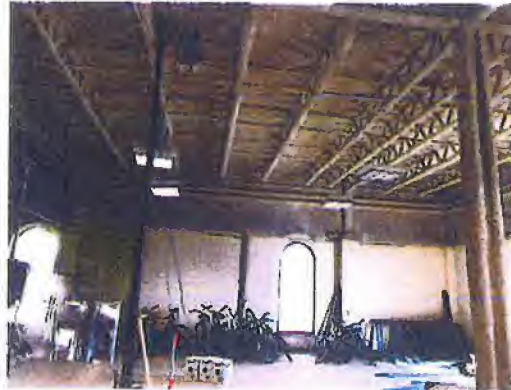
The branch circuits and feeders in this area of the facility appeared to be copper in metal raceway and original to the building.

Type "MC" cable appeared to be used for minor circuit revisions in these spaces.

Based on the existing drawing and electrical practice at the time of construction, we expect that the branch circuits included multi-circuit homeruns with a common neutral and no branch circuit equipment grounding conductor. With the new electronic ballast for the lighting, third harmonics created on the common neutrals could result in the neutral conductors being overloaded. If equipment grounding conductors are not included in the branch circuits, the loss of grounds could be expected due to the deterioration of the metal raceway in this area of the building.

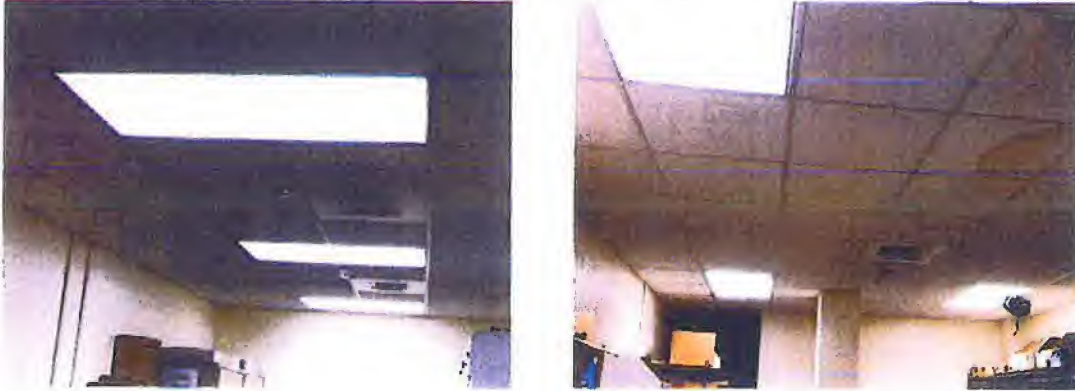
Lighting in the first floor office and administrative spaces generally consisted of recessed troffers with T-8 fluorescent lamps and electronic ballasts.

The lighting on the first floor appeared to be in fair condition with some maintenance required and dated lighting controls.

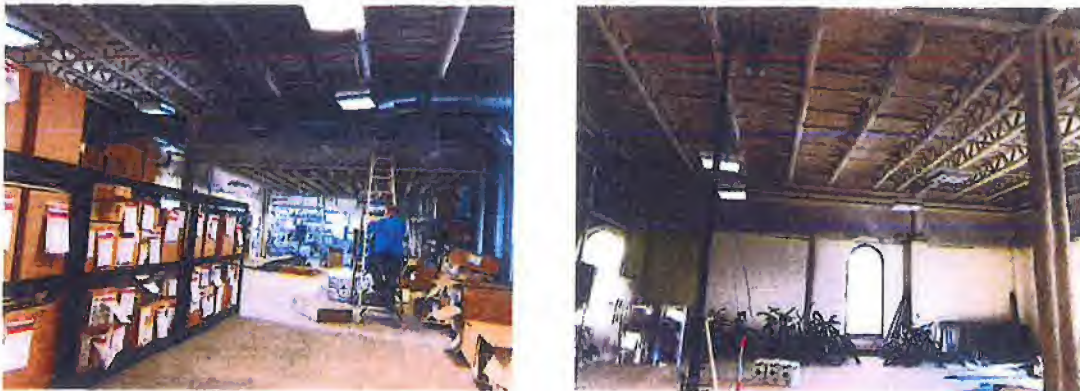
The lighting in the second floor and Police Storage areas generally consisted of 2x2, recessed, 3-lamp, parabolic fixtures with three T-8 fluorescent lamps and electronic ballasts suspended with wires.

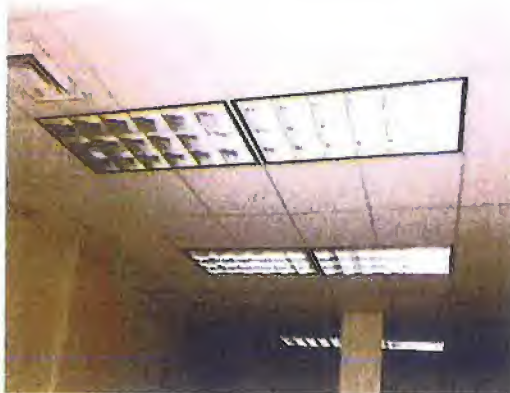
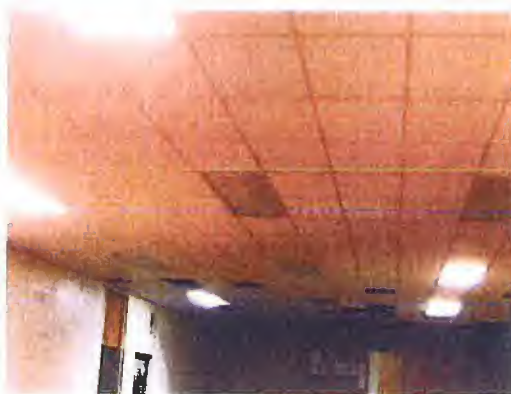
Lighting in the office, corridor and associated areas generally consisted of recessed, 2x4 parabolic troffers with T-8 fluorescent lamps and electronic ballasts.

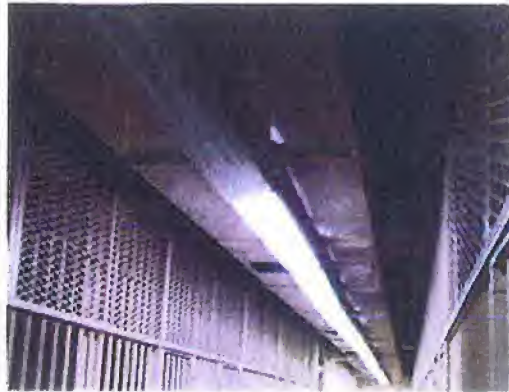
Lighting in the Jail Corridors generally consisted of 1x4, vapor-proof with T-8 fluorescent lamps and electronic ballasts.

The lighting appeared to be in fair condition.

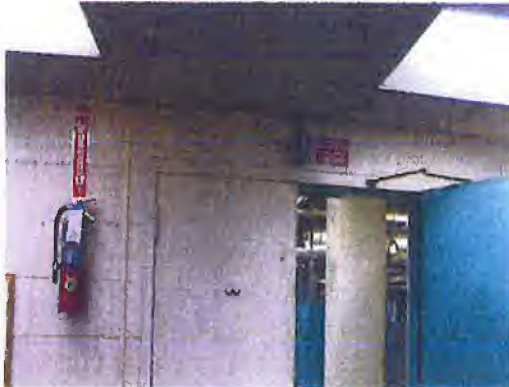
The lighting in area with a finished SAP ceiling consisted of 2x4 recessed troffer.
